RE: Field Oversight Report

Injection Wells Installation Event

Former Hewlett Packard Voluntary Remediation Project

FIELD OVERSIGHT REPORT

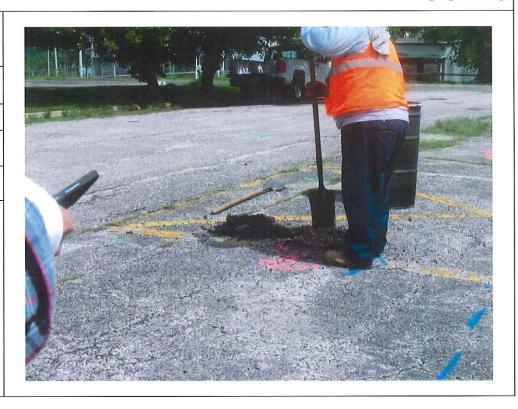
Photo No. 1

- Once determined the location of the well, the drilling personnel started the drilling process manually, until reaching 4 ft depth. See photos #1 and #2.
- The soil coming out of the hole was contained in 55 gallons drums. See photo #3.
- Assembly of the drill rig was prepared. See photos #4 and #5
- Using the 4 in drilling rod the drilling begins. See photo #6.
- Finally, the well goes down to 20 ft and water was encountered.
- Using 20 ft of 4 in diameter piping the injection well was installed. See photos #7 and #8.
- Once the piping completed, the annular space was filled with 12 ft of sand (see photo #9), 8 ft of bentonite and wetted with water (see photos #10 and #11) and completed with cement.
- The cover and casing of the monitoring well was going to be installed the next day to allow time for the pipe to settle.
